Manhole Inspection Summary

Manhole # S21CC_026MH

Insp Date: **10/24/07 10:01 AM**

Location Address: **1822 WINCHESTER-RIGGS**

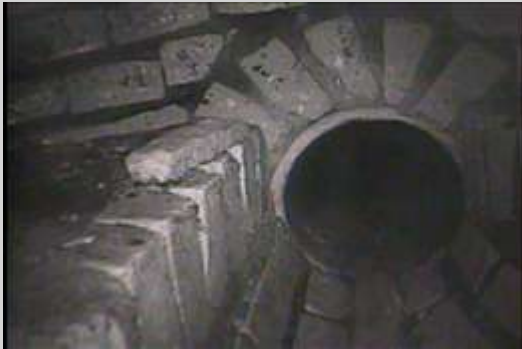
12 O'Clock Outflow

8 in. Circular Gravity Sewer
Pipe Out @ 12 O'Clock

Pipe Height: **8.4** (in.) Rod and Bar (Angled)
Pipe Material: **Clay** ☐ Pipe Lined
Invert Depth: **9.08** (ft.) Flow Characteristics: **Slow**
Deposits: ☒ None ☐ Mud ☐ Sludge ☐ Debris ☐ Grease
Silt Depth: (in.) Deposits Extent:
Infiltration: **None** Pipe Seal Cond: **Sound**

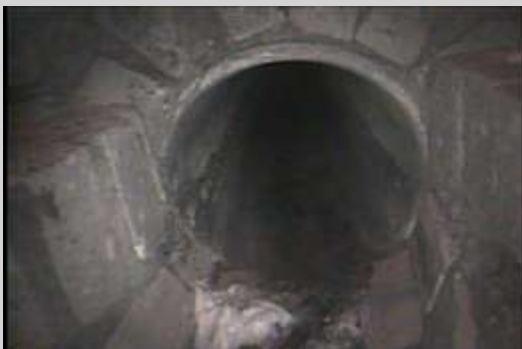
3 O'Clock Inflow

8 in. Circular Gravity Sewer
Pipe In @ 3 O'Clock

Pipe Height: **8.4** (in.) Rod and Bar (Angled)
Pipe Material: **Clay** ☐ Pipe Lined
Invert Depth: **8.86** (ft.) Flow Characteristics: **Slow**
Deposits: ☒ None ☐ Mud ☐ Sludge ☐ Debris ☐ Grease
Silt Depth: (in.) Deposits Extent:
Infiltration: **None** Pipe Seal Cond: **Sound**

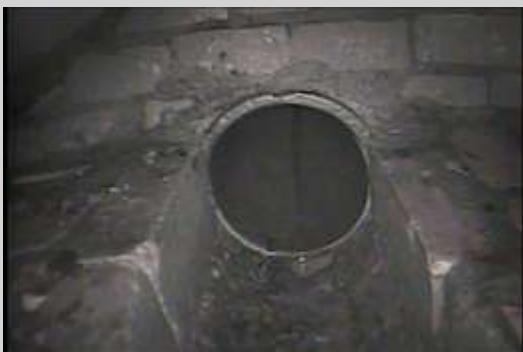
9 O'Clock Inflow

6 in. Circular Gravity Sewer

Pipe Height: **6** (in.) Rod and Bar (Angled)

Infiltration: **None** Pipe Seal Cond: **Sound**
